A Naval Safety Center Publication

# approach

APRIL 1972 / THE NAVAL AVIATION

# STACK against THE an ODDS: accident!

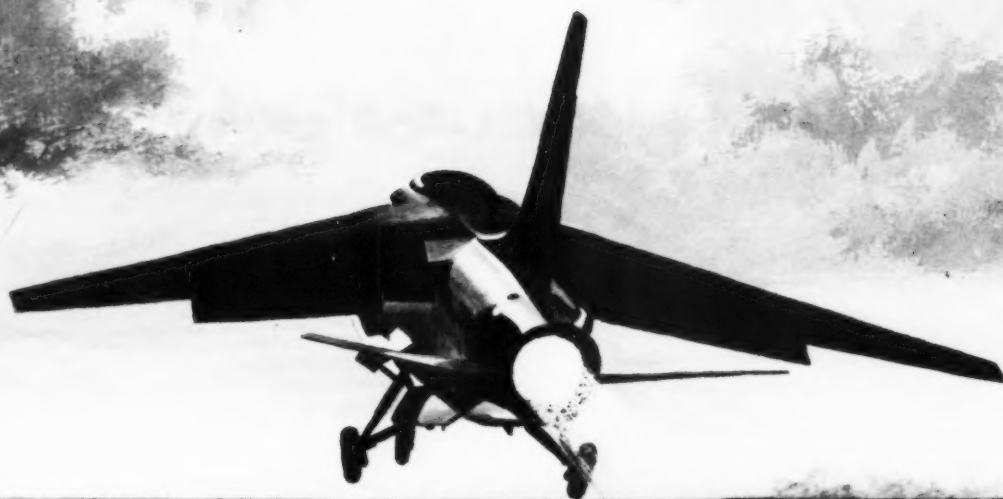
The most probable reason was the existing switch configuration on the ordnance panel. That is, the switches for station two through five were a new type which featured a rotary locking knob on the end of each switch (see photos at beginning of article). Station one, however, had a standard lift-to-unlock toggle switch. This unusual configuration came about in this manner: AFC (Airframe Change) 438 of 27 Oct 1969 directed that all station select switches be changed to the type which feature the rotary locking knob. This was done; however, at some later date, it became necessary to replace the switch for station one. The IPB (Illustrated Parts Breakdown) was consulted for switch nomenclature and part number. The IPB still referenced the old standard lift-to-unlock switch, and this was the switch ordered and installed in the panel. A check of the IPB after the accident showed that the information pertaining to the switch had not been updated since the issue of AFC 438.

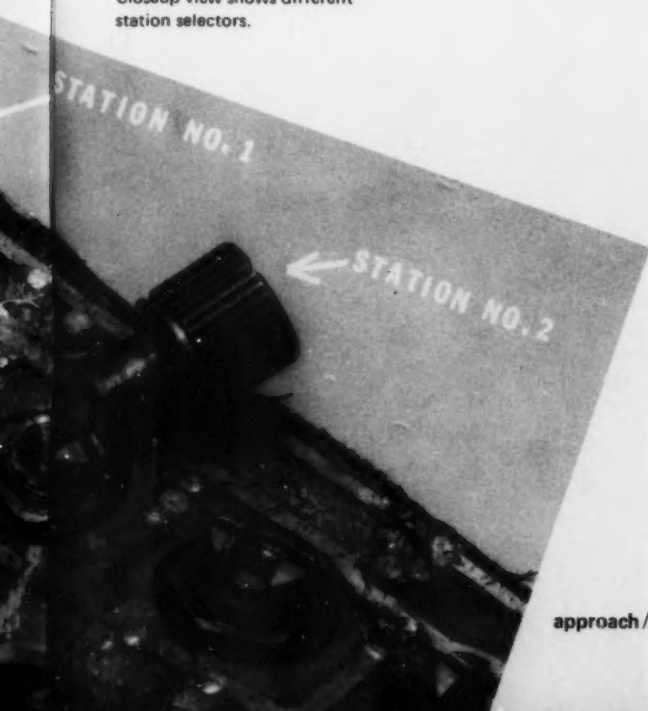
1

Closeup view shows different station selectors.

For this flight, practice ordnance (Mk-76s) were hung on wing stations one and five and 300-gallon droptanks on stations two and four. The pilot intended to select Mk-76 bombs on station one but unintentionally selected station two, which contained a droptank.

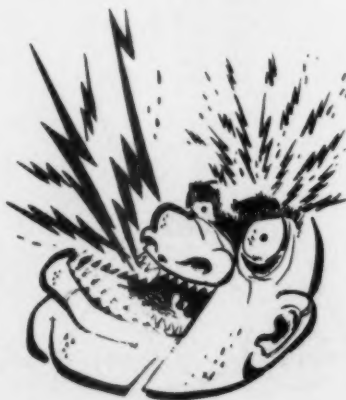
The day remained bright and sunny outside, but the air became blue, as sparks flew inside a certain office when an investigation disclosed the internal fuel tank was not hooked up. The unconnected fuel line had allowed fuel to drain out onto the cabin deck.

The CO said, "... this incident should not have occurred. An improper preflight by the crew chief and pilot resulted in this unnecessary incident. The proper preflighting of aircraft by all crew chiefs and pilots has been stressed in the past and will continue to be stressed by this command."
